## Engineering Strength to Survive the Storm

Jim Smith, Engineering Manager, Eagle Alloy, Inc.  
Shelly Dutler, Client Development Manager, MAGMA Foundry Technologies, Inc.

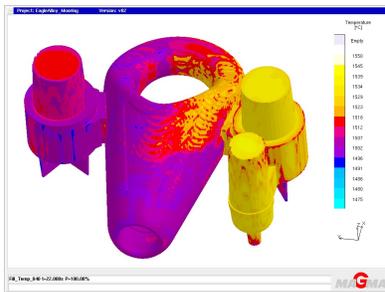
The primary root cause for the cracks was found through the evaluation of the stresses created in the casting during cooling. The casting geometry and rigging is symmetrical, but the entire system was filled through one side riser. The asymmetrical filling of the system produced a "cold side" and a "hot side" at the end of the filling with substantial and lasting effects through solidification and cooling. The maximum principal stress results confirmed a localized region of tensile stress at the riser contact, and these stresses were higher on the hot side. Additionally, the maximum principal stress vectors showed the direction of the tensile stress to be perpendicular to the crack. All these factors showed that the thermal stresses created during cooling led to the creation of the crack in the casting.

*Illustration 1: Temperature Distribution at the End of Filling with the Original Pouring Process*

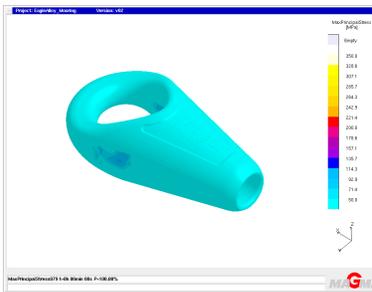
*Illustration 2: Residual Maximum Principal Stress at the Cold Riser*

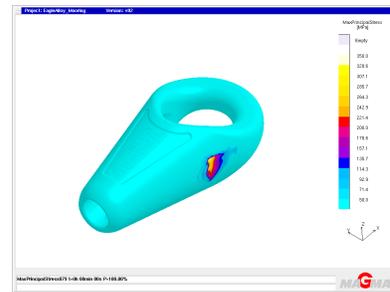
*Illustration 3: Residual Maximum Principal Stresses at the Hot Riser*

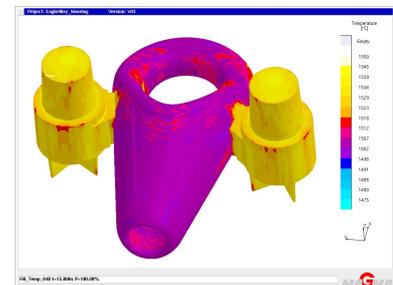
*Illustration 4: Temperature at the End of Filling, Double Pour*

Using the information found in the initial evaluation, the tooling and metallurgical engineers at Eagle Alloy, Inc. and the project engineer at MAGMA discussed several options regarding possible changes that could be made cost-effectively while still creating a robust and manageable process. Various suggestions included insulating the riser contacts during solidification and cooling, leaving the risers on during heat treatment, changing the riser contact shape and size, and other modifications to the pouring process. The easiest process change, pouring through both risers, was investigated. This pouring created a more balanced temperature distribution and was easily implemented in the foundry. The stress simulation during the cooling of the casting still showed a region of higher tensile stress, but the values were equal on both sides. The change to the process was then made in the foundry, and castings were produced with the risers removed prior to heat treatment. The amount of cracks was significantly reduced and when visible, they were smaller in size. However, this was still unacceptable. The engineers at both MAGMA and Eagle Alloy again discussed the possibilities for process changes. With the single riser pour method, removing the risers after heat treating had still produced occasional cracks at the riser contacts. It was determined that the dual riser pour method should continue but additional processing changes were made, and today's castings are free of cracks.
